NASA TN D-4964

# DEVELOPMENT OF IMPROVED THROAT INSERTS FOR ABLATIVE ROCKET ENGINES

*by Jerry M. Winter and Donald A. Peterson*

*Lewis Research Center*

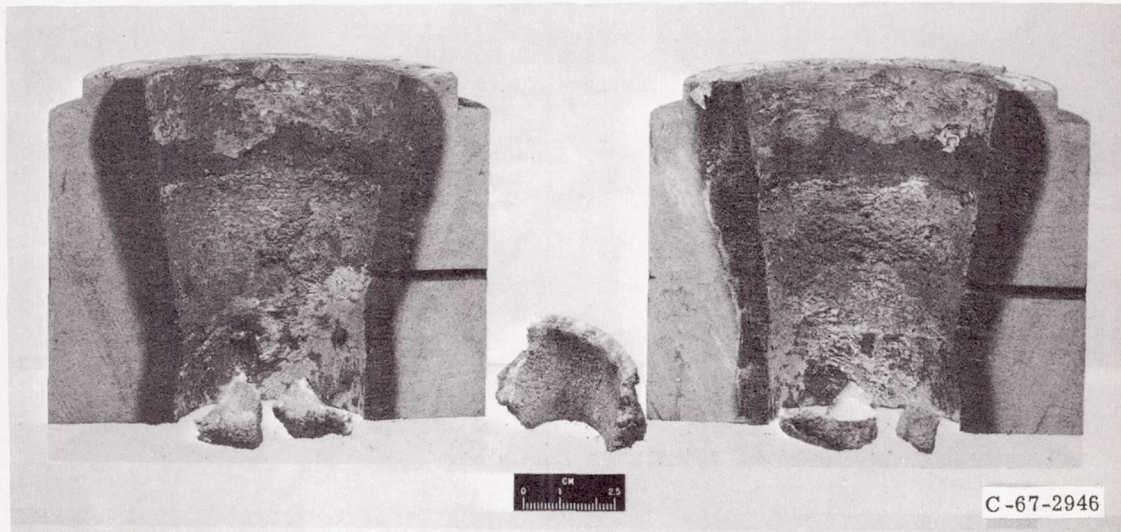
(40) Insert 40; injector 2

Material	Form	Manufacturer	Configuration (a)	Additional layers
Insert		ZrO <sub>2</sub>	70 % theoretical density; partially yttria stabilized; coarse grain; pressed and sintered	Zircoa	B	JTA liner upstream of throat
Envelope		Silica phenolic (MX 2641)	Molded squares	-----	5-in. (12.7-cm) o.d.	None
Run	Chamber pressure, P <sub>c</sub>		Run time, sec	Total change in effective throat radius, ΔR		Remarks
	psia	kN/m <sup>2</sup>		in.	cm	
746	101	696	160	0.088	0.223	Shutdown at first sign of rapid erosion; severe cracking

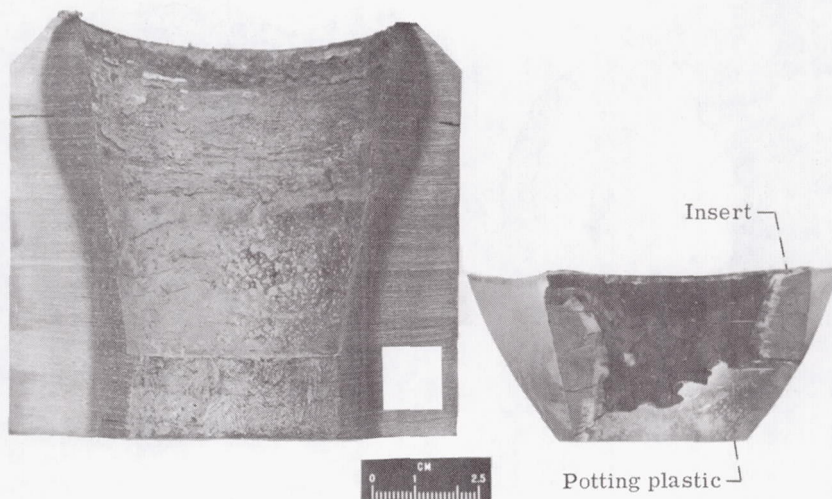
(58) Insert 58; injector 2

Material	Form	Manufacturer	Configuration (a)	Additional layers
Insert		ZrO <sub>2</sub> - platinum-coated molybdenum honeycomb	Sintered	Avco Corp.	B	JTA liner upstream of throat insert
Envelope		Silica phenolic (MX 2641)	90° centerline	Fiberite	4-in. (10.15-cm) o.d.	None
Run	Chamber pressure, P <sub>c</sub>		Run time, sec	Total change in effective throat radius, ΔR		Remarks
	psia	kN/m <sup>2</sup>		in.	cm	
405	100.6	692	137.6	0.059	0.15	Shutdown for erosion; loss of insert trailing edge

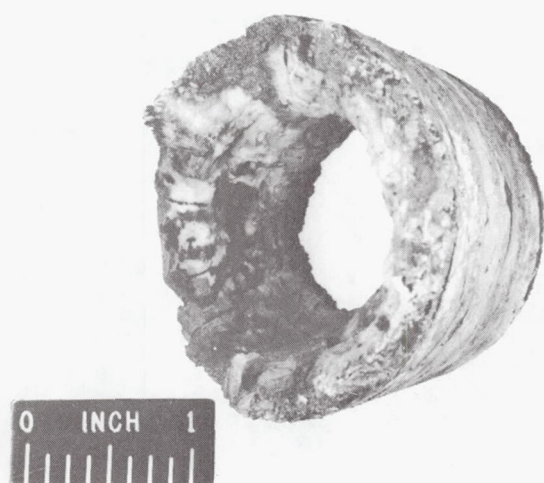
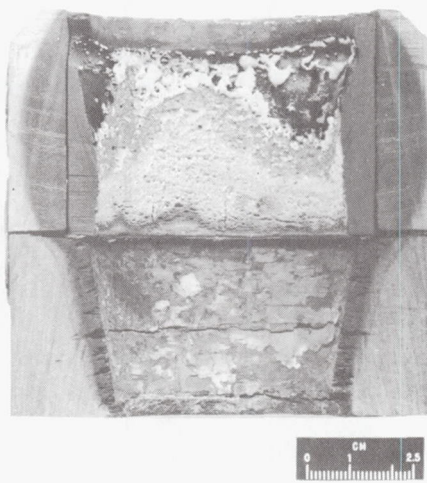
(59) Insert 59; injector 1A

Material		Form	Manufacturer	Configuration (a)	Additional layers
Insert	MgO - 1010 steel honeycomb		Sintered	Avco Corp.	A	Molded graphite-silica composite upstream of throat insert
Envelope	Silica phenolic (MX 2641)		90° centerline	Fiberite	4-in. (10.15-cm) o.d.	None
Run	Chamber pressure, P <sub>c</sub>		Run time, sec	Total change in effective throat radius, ΔR		Remarks
	psia	kN/m <sup>2</sup>		in.	cm	
119	101.5	699	60.3	-0.025	-0.0635	Timed shutdown
143	95.6	658	261.0	-.031	-.0788	Shutdown for leak in nozzle; leading edge of in- sert badly eroded
			321.3

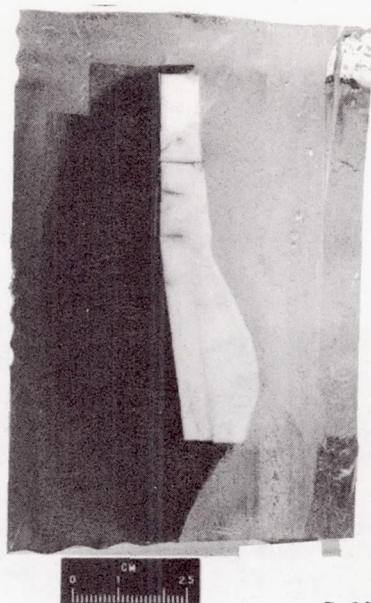
(68) Insert 68; injector 2

Material	Form		Manufacturer	Configuration (a)	Additional layers
Insert			BeO	3 axial washers each segmented 120 <sup>o</sup>		Aerospace Corporation	B	1/4-in.(0.635-cm)thick BeO cone on outside diameter of BeO; BeO liner upstream of throat insert
Envelopes			Silica phenolic (MX 2641)	Molded squares		-----	5-in. (12.7-cm) o.d.	None
Run	Chamber pressure, P <sub>c</sub>		Oxidant-fuel ratio, O/F	Run time, sec	Total change in effective throat radius, ΔR		Remarks	
	psia	kN/m <sup>2</sup>			in.	cm		
745	102	702	2.03	300.5	0.002	0.00508	Timed shutdown; cracking and loss of pieces	
754	104.5	720	2.02	20.0	-----	-----	Timed shutdown	
755	104	717	2.06	20.7	-----	-----	Timed shutdown	
756	105	723	2.02	20.8	-----	-----	Timed shutdown	
757	105	723	2.00	20.3	-----	-----	Timed shutdown	
758	105	723	1.98	20.0	.012	.0305	Timed shutdown	
810	100	689	2.08	7.9	-----	-----	Timer malfunction	
811	101.5	698	2.02	280.9 691.1	.061	.155	Out of propellant

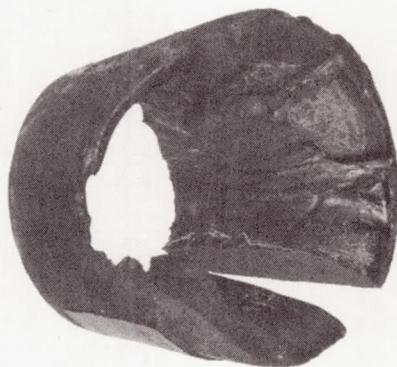
(70) Insert 70; injector 2

Material		Form		Manufacturer	Configuration (a)	Additional layers
Insert		Tungsten-coated BeO spheres (25 wt. % W)		Sintered		National Beryllia	B	JTA liner up- stream of throat insert
Envelope		Silica phenolic (MX 2641)		Molded squares		-----	4-in. (10.15-cm) o.d.	1/4-in. (0.635-cm) thick asbestos phenolic
Run	Chamber pressure, $P_c$		Oxidant-fuel ratio, O/F	Run time, sec	Total change in effective throat radius, $\Delta R$		Remarks	
	psia	$\text{kN/m}^2$			in.	cm		
635	99 to 102	684 to 702	1.98	225.3	0.017	0.043	Erosion due to oxidation of tungsten; no cracking

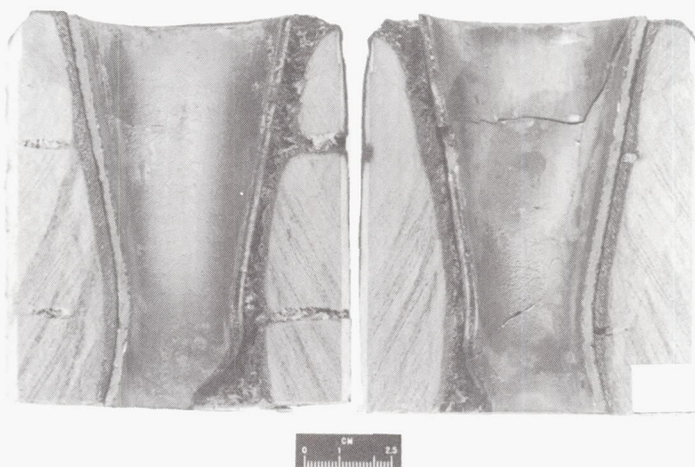
(77) Design 77; injector 2

Material		Form		Manufacturer		Configuration (a)		Additional layers	
Coating		0.040-in. (0.1015-cm) thick SiC		Pyrolytic		Cincinnati Testing Laboratories		J		0.040-in.(0.1015-cm) thick SiC on outside diameter of liner	
Insert		Graphite									
Envelope		Quartz- polypropylene phenolic		Cloth, 60 <sup>0</sup> centerline reversed		Cincinnati Testing Laboratories		4-in. (10.15-cm) o.d.		1/8-in. (0.317-cm) thick asbestos phenolic	
Run	Chamber pressure, P <sub>c</sub>		Oxidant-fuel ratio, O/F	Run time, sec	Total change in effective throat radius, ΔR		Remarks				
	psia	kN/m <sup>2</sup>									
					in.	cm					
650	100	689	2.00	15.9	-0.005	-0.0127	Shutdown due to gas leakage; axial cracks in insert

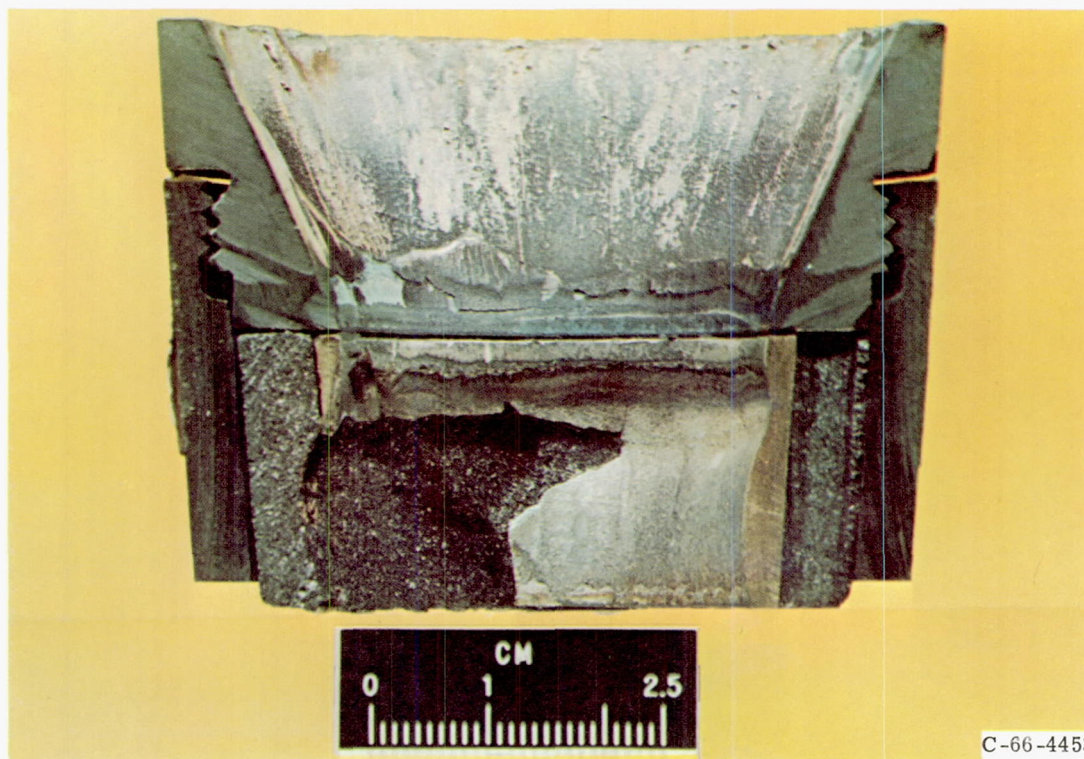
(79) Design 79; injector 2

Material	Form	Manufacturer	Configuration (a)	Additional layers
Insert			TaC; carbon brick; FS-85 ring; pyrolytic graphite	a-b plane radial	TRW	E	Carburized Ta - 10 wt. % W upstream of insert: JT0981 upstream of Ta - 10 wt. % W
Envelope			Silica phenolic	0° centerline	TRW	-----	Steel shell
Run	Chamber pressure, $P_c$		Oxidant-fuel ratio, O/F	Run time, sec	Total change in effective throat radius, $\Delta R$		Remarks
	psia	kN/m <sup>2</sup>			in.	cm	
331	100.5	693	2.02	125.1	0.005	0.127	Shutdown at first sign of erosion
350	100.1	690	2.10	$\frac{102.5}{227.6}$	.065	.175	Shutdown when erosion rate was established
